North Valley Public Library  
Substructure  
11-14-2006

Substructure accesses are through hatches in the Montana room for the southern unit, and behind the front desk for the middle unit. The north unit has a slab floor, as far as I know.

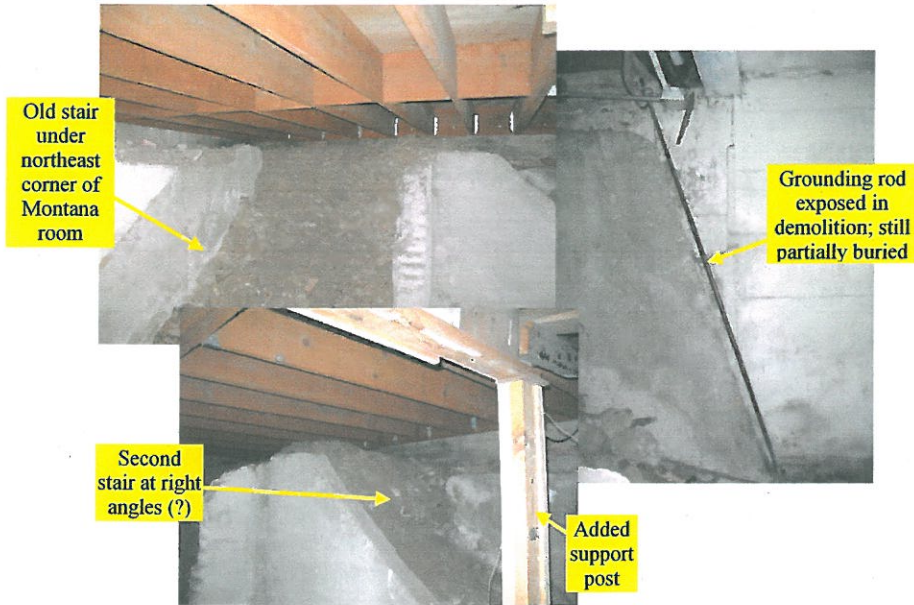
When some demo was done, the grounding rod for the electrical system was exposed. This is supposed to be buried ten feet or more in the ground. It is still in the ground, but it is likely only a few feet in. This is something we should check out with our electrician.

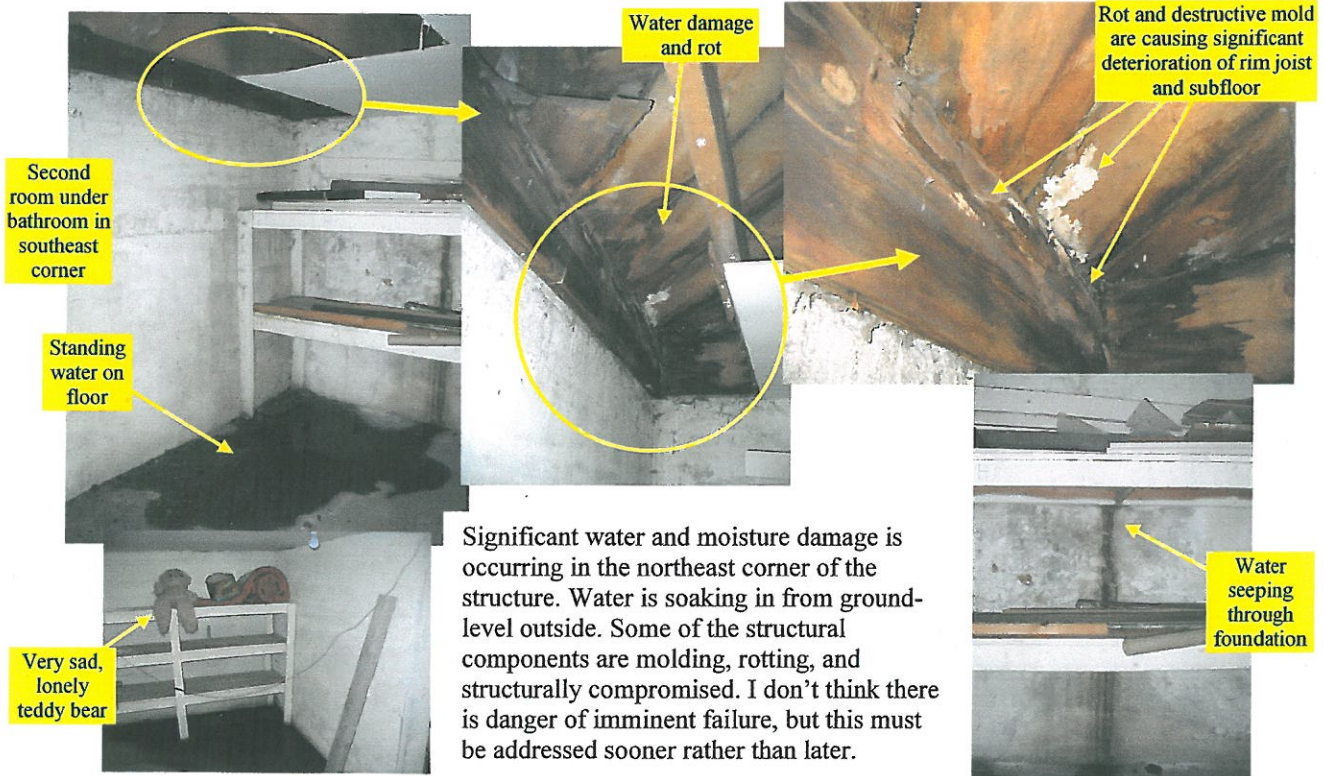
Significant water and moisture damage is occurring in the northeast corner of the structure. Water is soaking in from ground-level outside. Some of the structural components are molding, rotting, and structurally compromised. I don't think there is danger of imminent failure, but this must be addressed sooner rather than later.

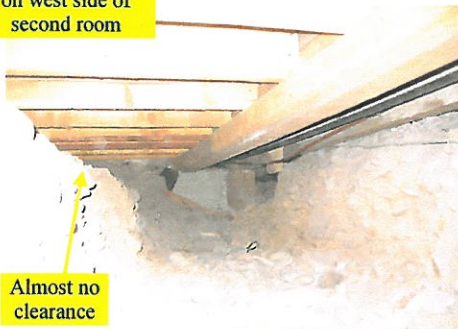
Almost no clearance

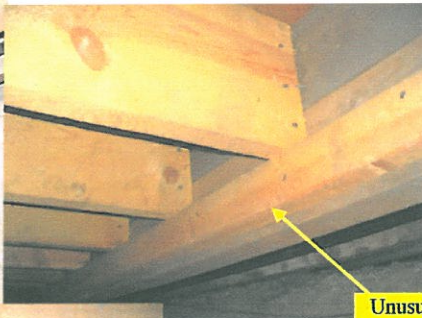
Unusual but apparently sound framing under stacks

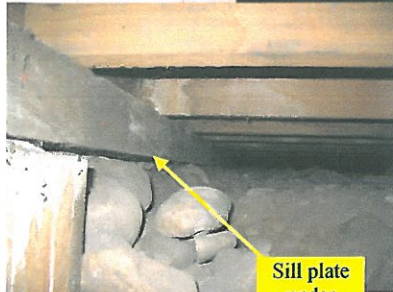
Sill plate under former back wall (?)

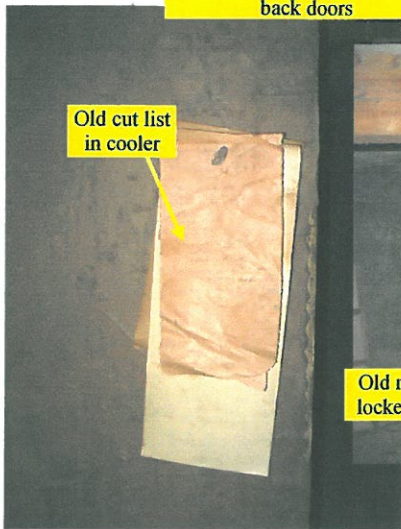
Old cut list in cooler

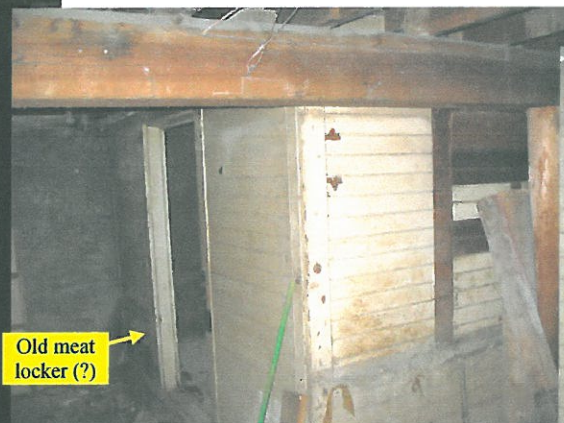
Old meat locker (?)

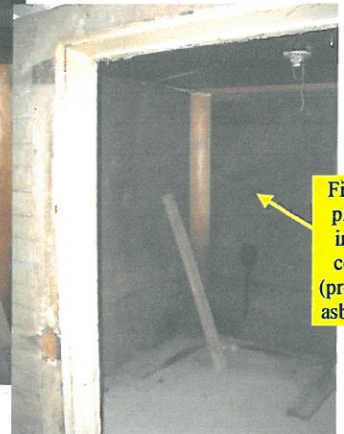
Fibrous plaster inside cooler (probably asbestos)

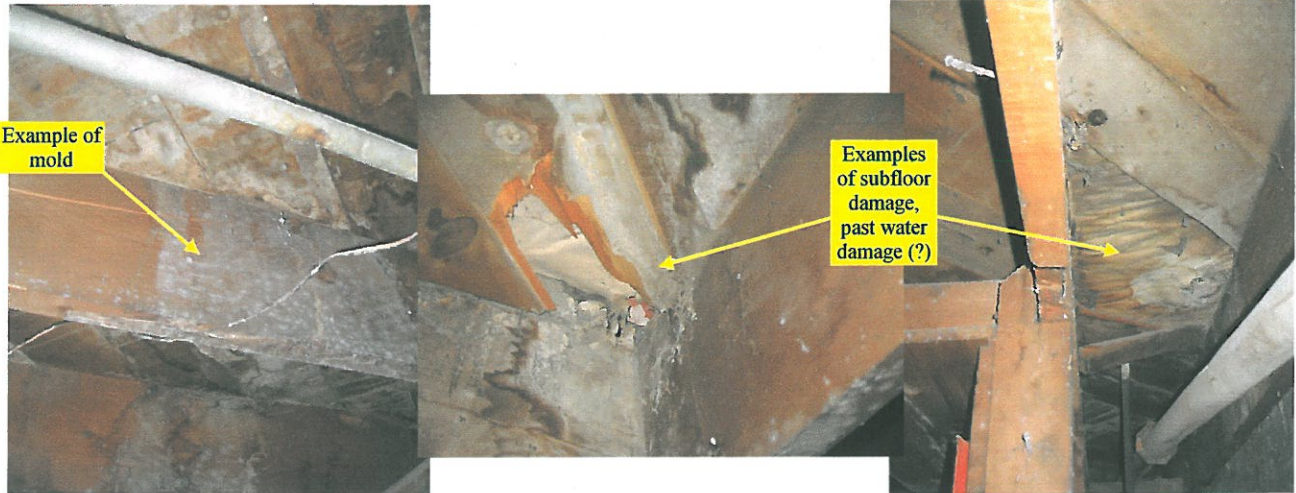
There is widespread evidence of water pouring down through gaps in the subfloor. There seems to be a lot of cement dust in it, so I'm guessing this was slurry water from sawing through the concrete when the buildings were joined.

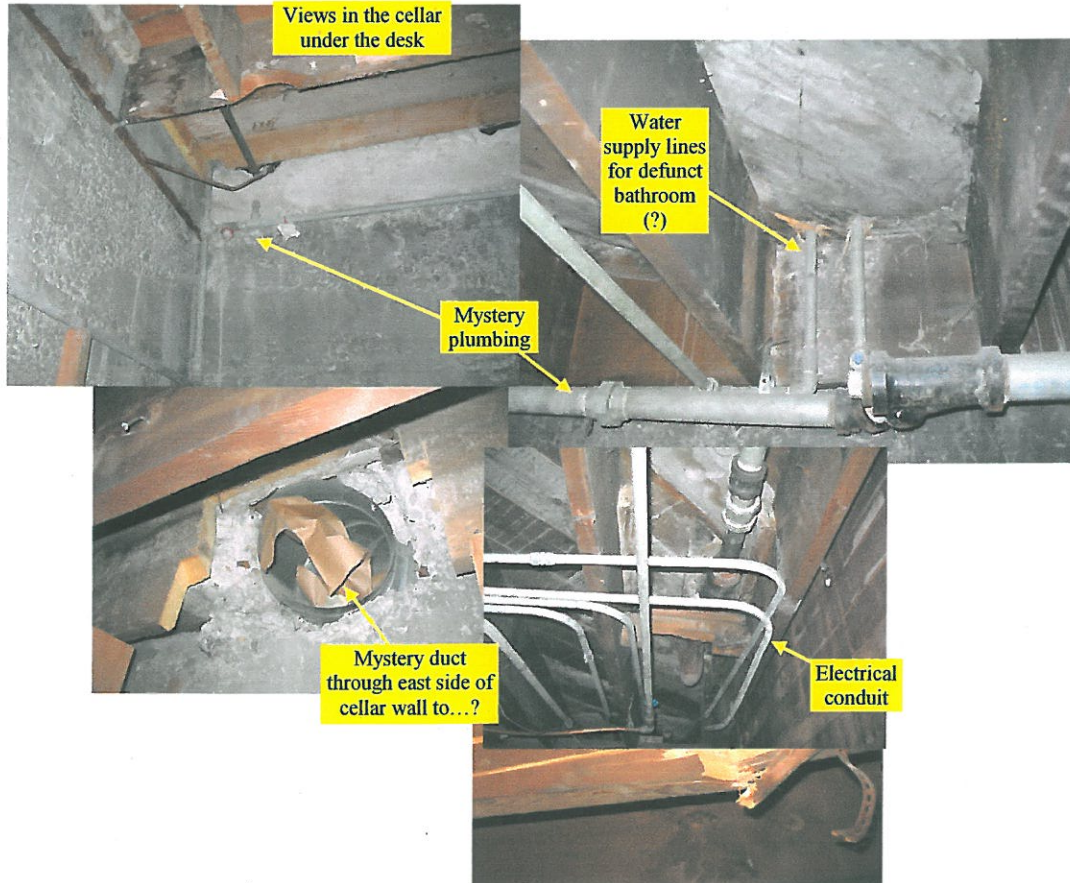
There are pipes and ducts running here and there beyond the cellar space, to the east (under the back workroom?), and the north (into the slab under the north unit?). There is also evidence of various sinks or other water fixtures in the little back room and office that have been removed and floored over.

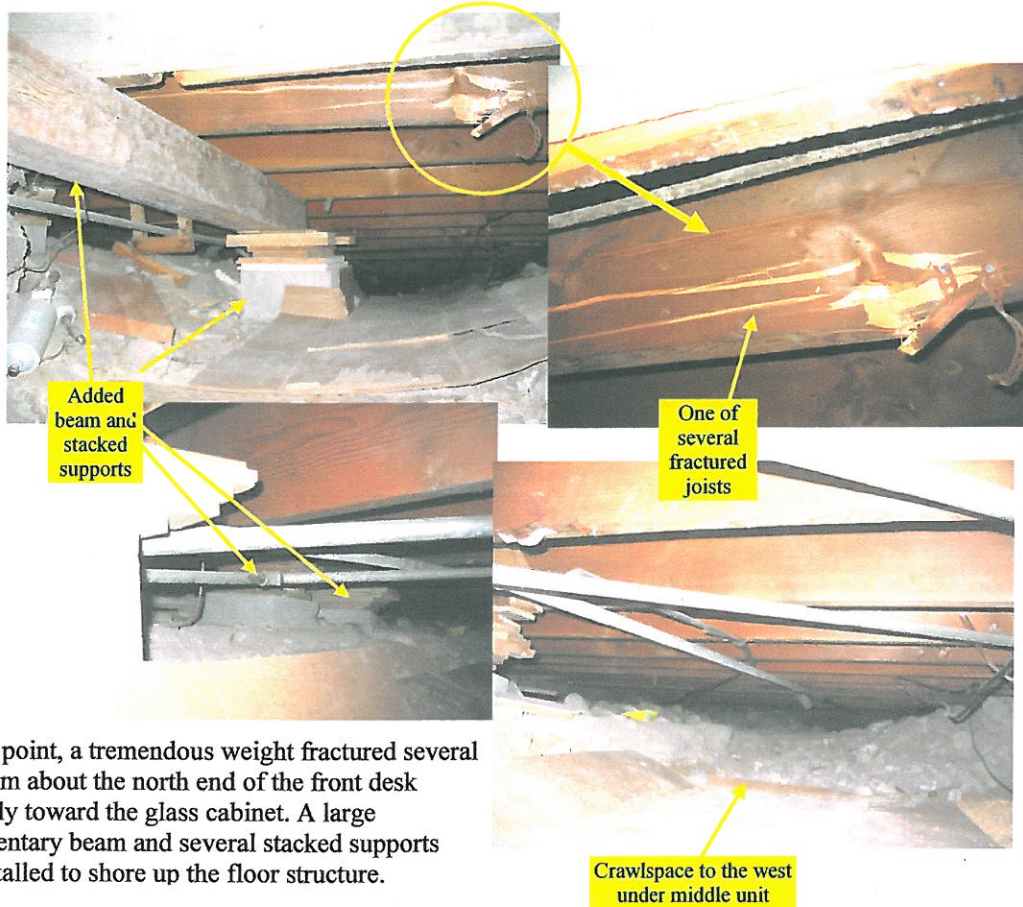
At some point, a tremendous weight fractured several joists from about the north end of the front desk diagonally toward the glass cabinet. A large supplementary beam and several stacked supports were installed to shore up the floor structure.

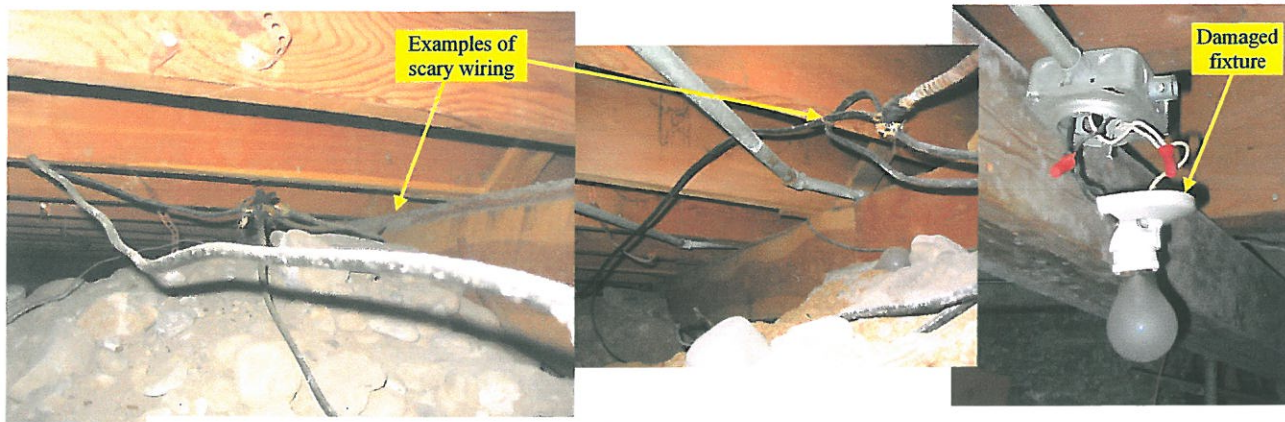
This wiring turned out to be abandoned (I'm pretty sure, anyway), but this is the kind of thing that will make a fireman step aback and let it burn, so we need to clean this sort of thing up. The light is live.
