Re: South Building Framing Investigation - North Valley Public Library

Per your request, an inspection was completed on the south building of the library. The inspection was completed on October 15, 2015 & November 9, 2015. The inspection was performed by George Mullen, EI. The main floor, basement and crawlspace were visually inspected. No destructive investigation was completed.

North Valley
Public Library
Floor Upgrade
South Building
Stevensville, MT

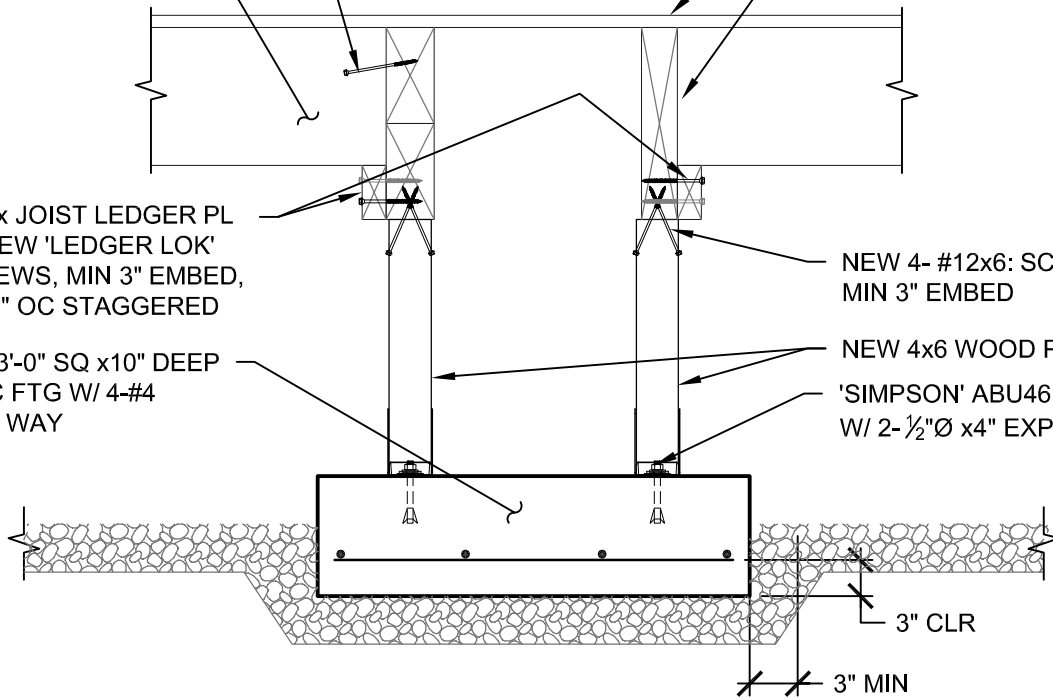
1. The existing main floor joist are adequate to support the expected loading, per design criteria noted above.
2. The girder beams below the main floor with the 14' and 16' spans falls short of being able to support design loading. Intermediate support posts are required. See Detail S1 for an additional support required in the accessible crawlspace. See Detail S2 for an additional support required in basement. All the columns should be installed at the mid-span of the existing beam. See Note #3 and Note #4 for additional beam and upper floor column support that may be required.

3. See Detail S1 and S2 for additional joist to girder beam fastening. See Details S1 and S2 for additional fastening to the existing 3x ledger plate supporting the floor joists.

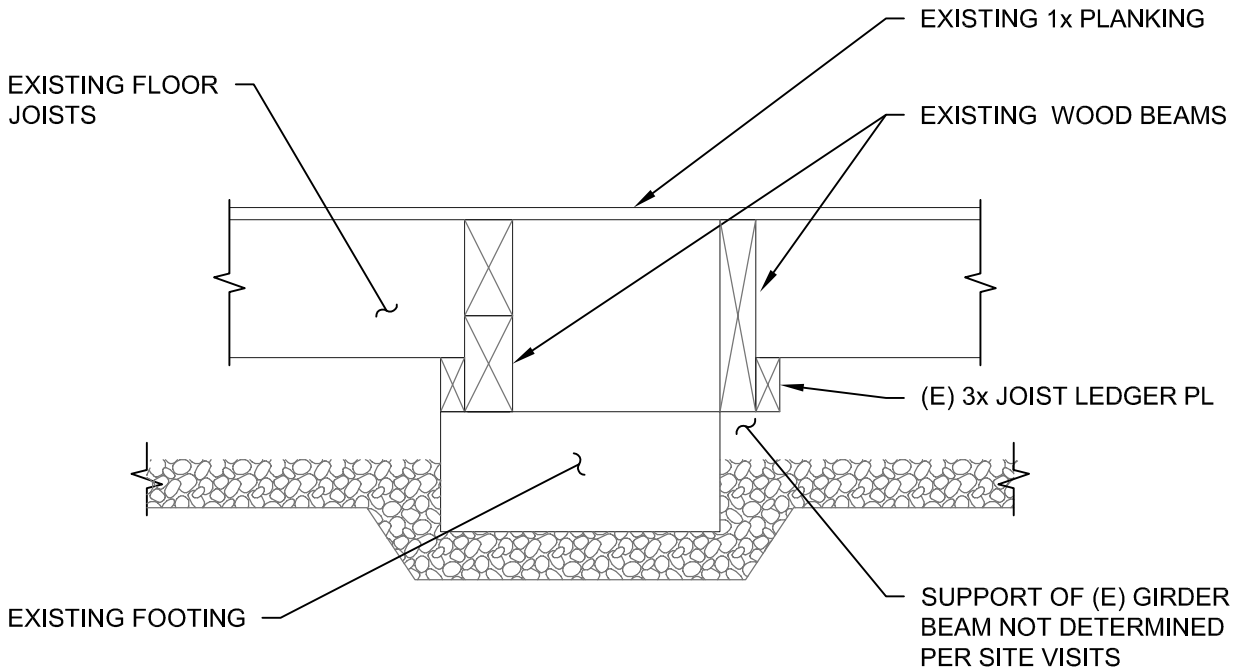
4. Because foundation support in the crawlspace could not be completely observed, additional support may be required. Detail S3 was developed to represent BCE's understanding of the existing conditions. Conditions may vary from detail provided.

- a. Based on calculations the maximum girder beam span should not exceed 10'-0". Once the finish floor is removed opportunity to observe the crawlspace will allow for further investigation.

- b. The double 4x6 appears to align with the existing concrete foundation, additional support may not be required.
 - c. The 3x16 girder beam does not appear to align with the existing footing. Once the existing conditions can be exposed additional coordination with BCE will be required to develop support at the existing foundation.
