Re: Site Observation (2nd)
North Valley Public Library
208 Main St.
Stevensville, Montana 59870

On Wednesday, January 4, 2017, a representative from Eclipse Engineering made a site visit to the above stated address. The purpose of the visit was to investigate the condition of the roof framing after an issue with a roof beam (excessive deflection) was found during renovation.

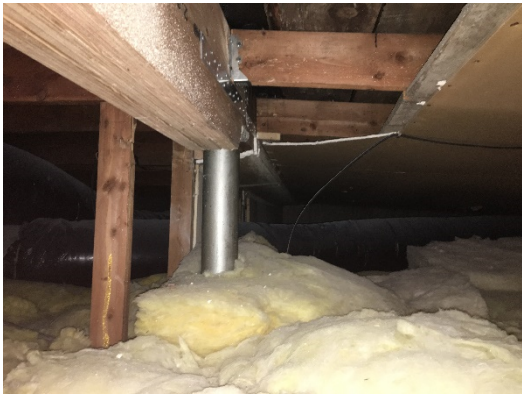
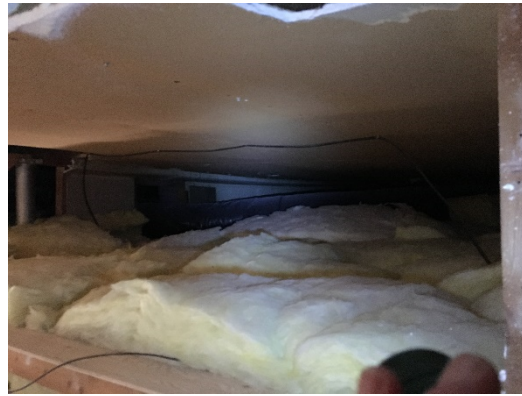
PUBLIC AREA WHERE BEAM IS LOCATED

Although the beam in question, (3) 2x10's, has not failed, the large deflection is a definite concern and it is recommended that it be replaced with a new (3) 1 ¾" x 11 7/8" LVL beam.

Attach all new and existing rafters to this beam with Simpson hangers. If required, the beam may be notched to match the bearing conditions of the existing (3) 2x10 beam, do not notch with a square cut, ref. detail A.

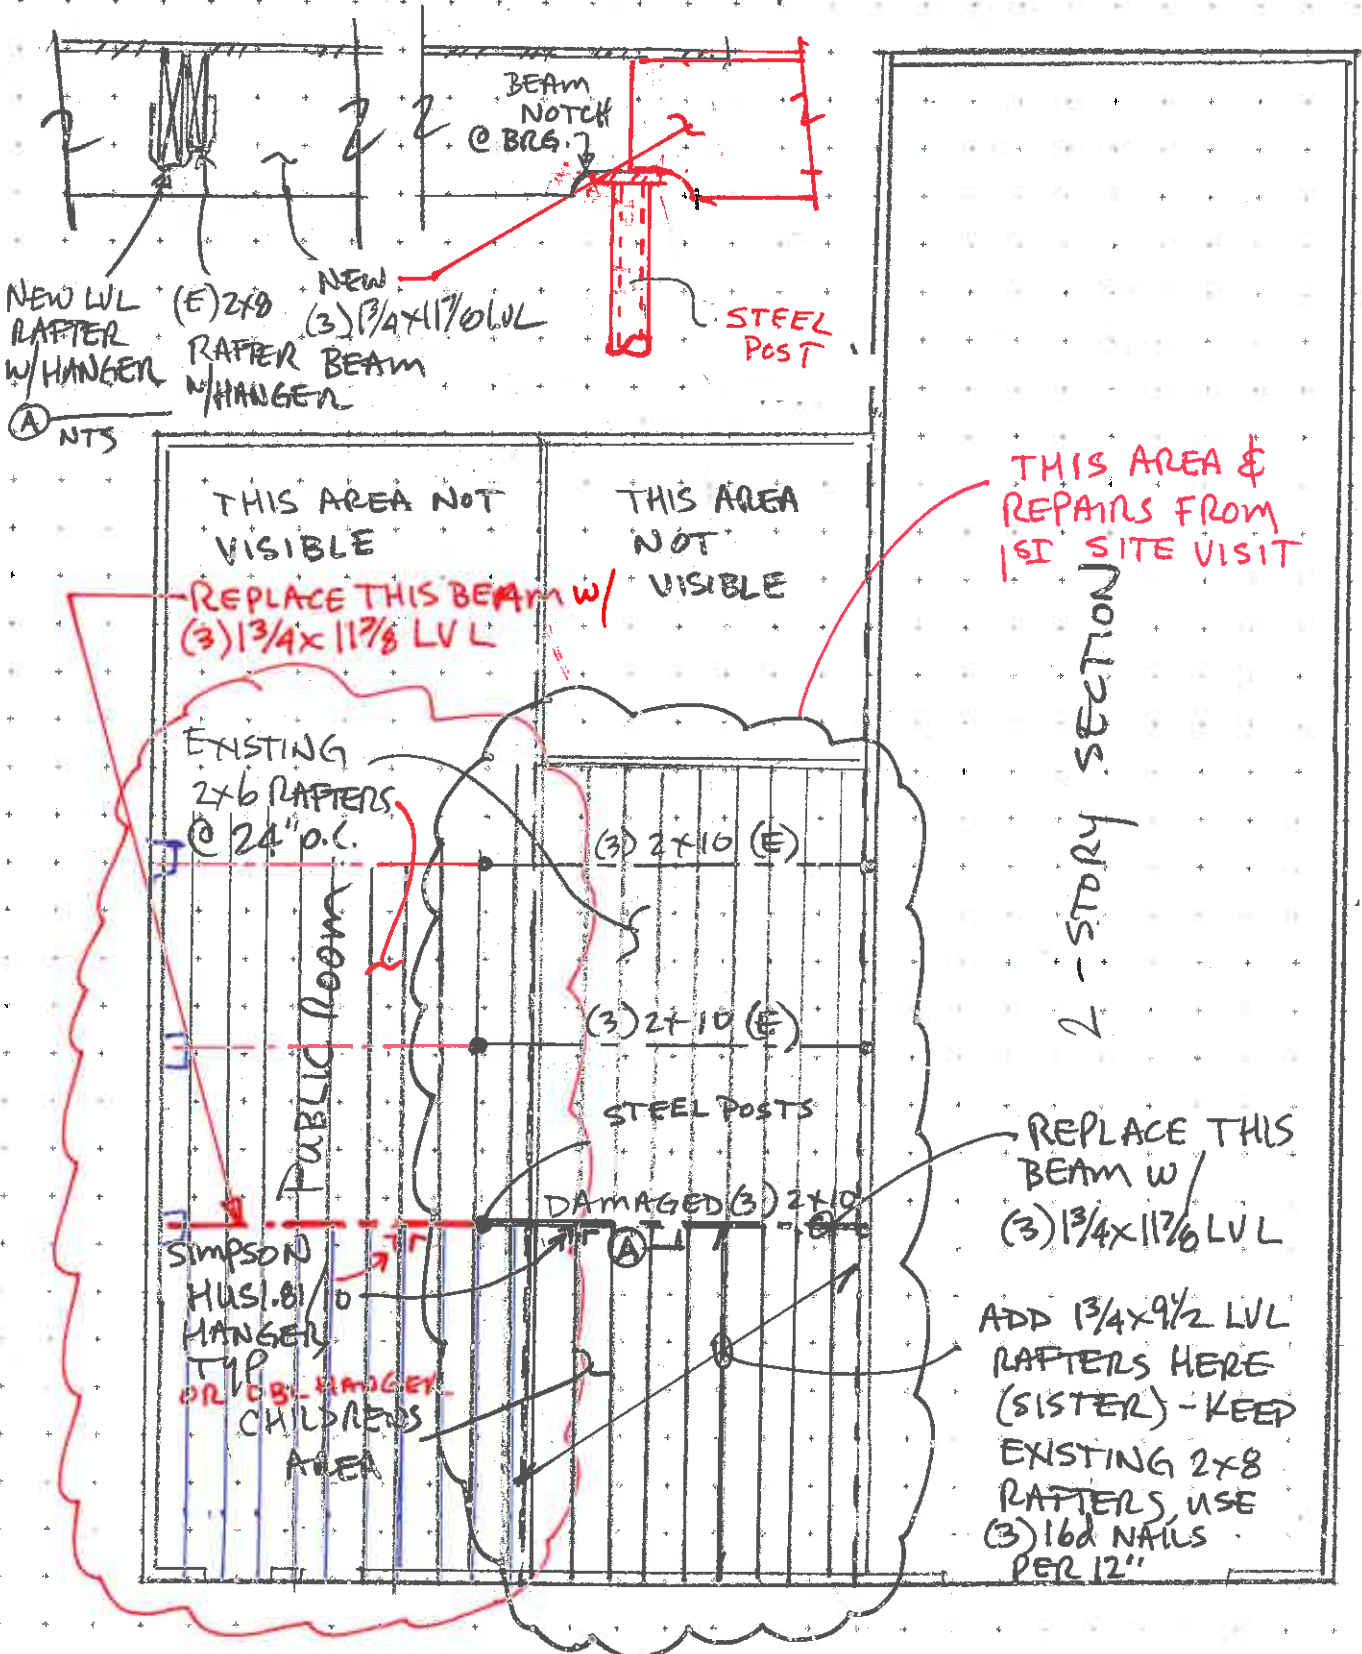
PARTIAL FRMG. PLAN - NOT TO SCALE

The 19 ft. rafter span is too long for 2x8's at 24" on center. Add (sister) 1 ¾"x 9 1/2" LVL rafters to each 2x8 rafter spanning 19 ft. Use appropriate Simpson hangers at the new beam. Nail existing rafter and new rafter with (3) 16d nails per 12".
