**August 28, 2023**

**Project #: 00776-040-0010**

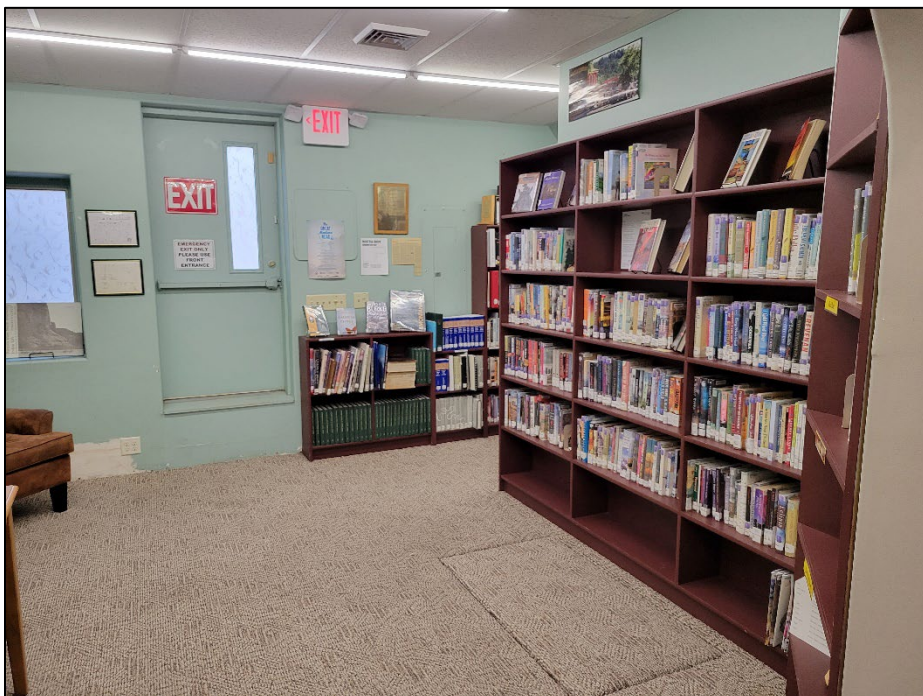
**Photo 10. April 11, 2023. Street level. "Montana Room" with access to one section of the basement and emergency exit. Green plaster walls with ceiling tiles. Minor amount of loose insulation above ceiling tiles. Basement has drywall storage rooms, peg board, brick columns, and painted concrete.**

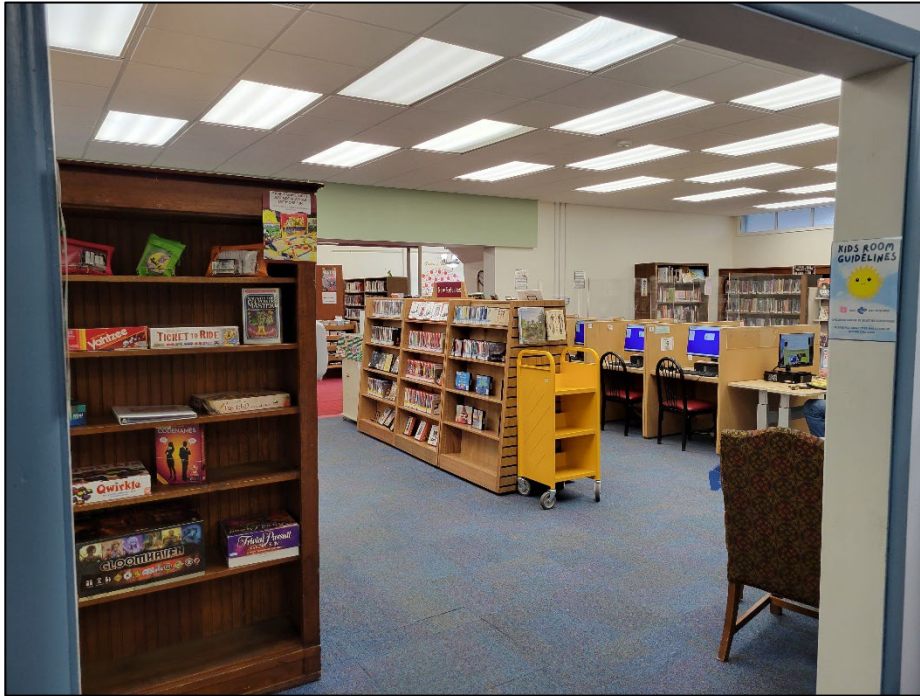
**Photo 11. April 11, 2023. Street level.** Computer station room with an access to a portion of the basement (square on blue carpet). White painted drywall and ceiling tiles. Wood and concrete beneath carpet. Basement has membrane on floor and a few feet up the walls with concrete walls and brick columns.

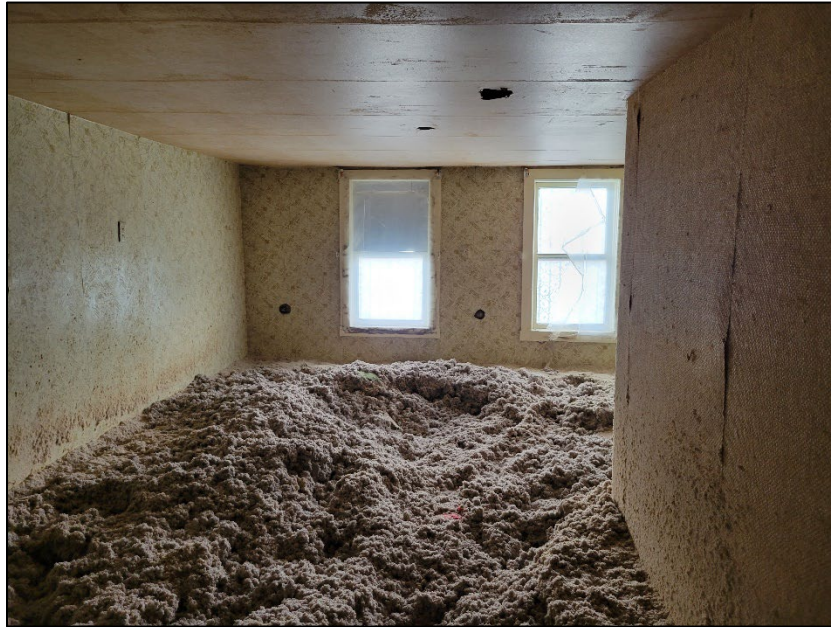
**Photo 17. April 11, 2023. First floor:** Approximately 12 to 18 inches of loose insulation covering the entire upper-level floor. Beneath the insulation is various carpeted flooring. Walls are covered in multiple styles of wallpaper which is covering plaster or drywall walls and ceiling.

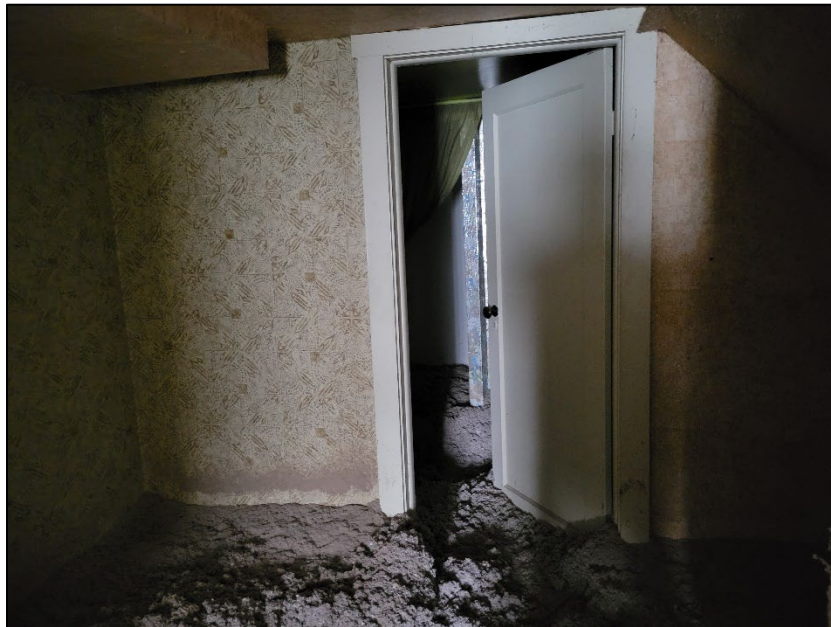
**Photo 18. April 11, 2023. First floor:** Approximately 12 to 18 inches of loose insulation carpeted floors. Upper floor bathroom behind doorway with shower. Multiple types of wallpaper covering drywall walls and ceilings.

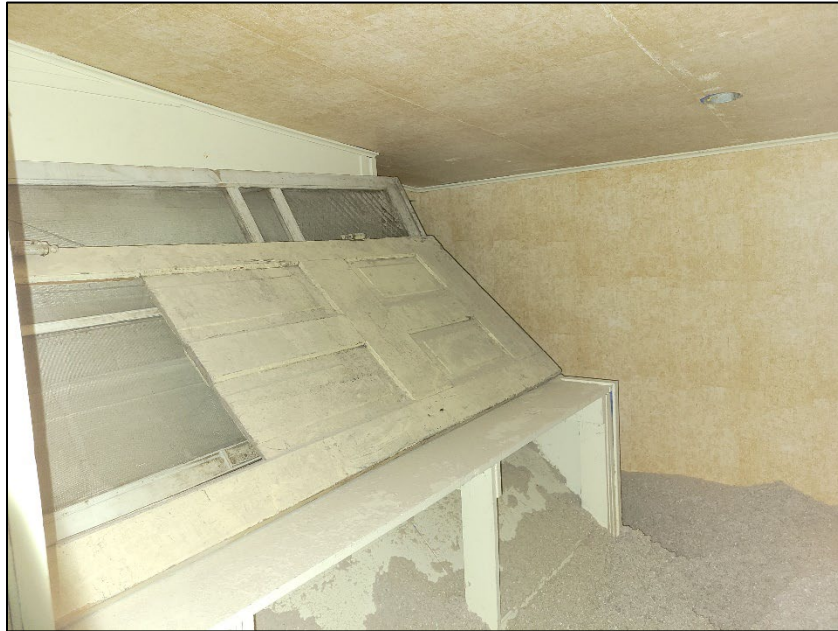
**Photo 19. April 11, 2023. First floor:** Approximately 12 to 18 inches of loose insulation covering the carpeted floor. Multiple doors being stored in room next to bathroom. Wallpaper covering drywall walls and ceiling.

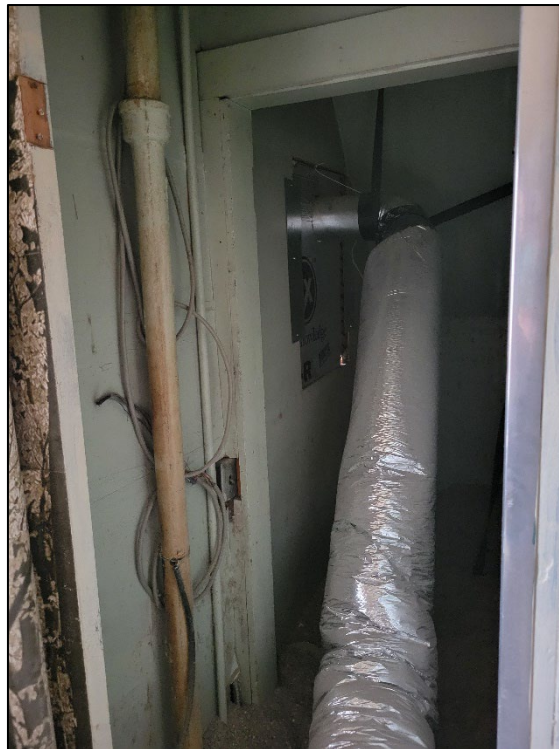
**Photo 20. April 11, 2023. First floor, eastern side:** utilities and access to attic.

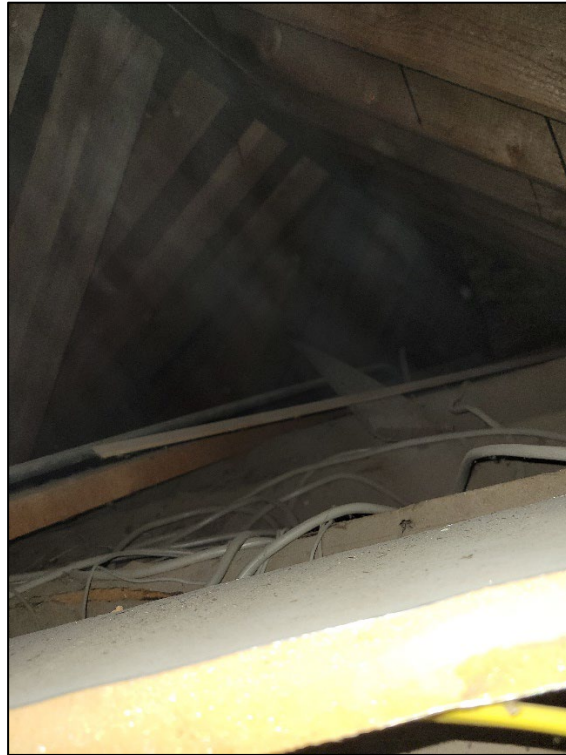
**Photo 21. April 11, 2023. First Floor attic:** Wood framed attic with loose insulation, black tar from roof, and utilities running over trusses.

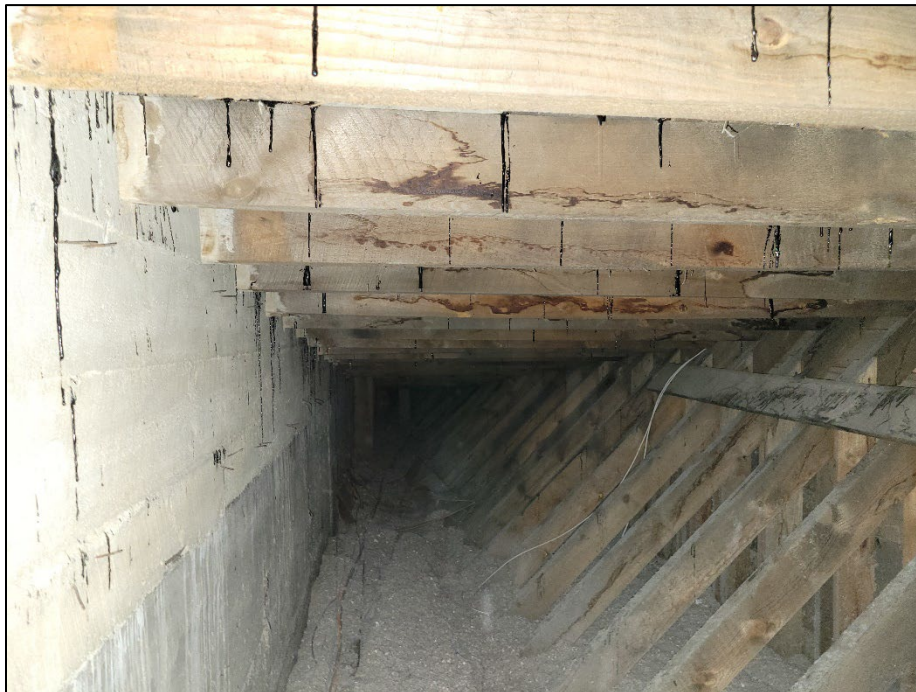
**Photo 22. April 11, 2023. First floor storage room:** Black tar from asphalt roofing on wood ceiling and trusses. Concrete wall. Loose asphalt shingles on floor (off image of photo).

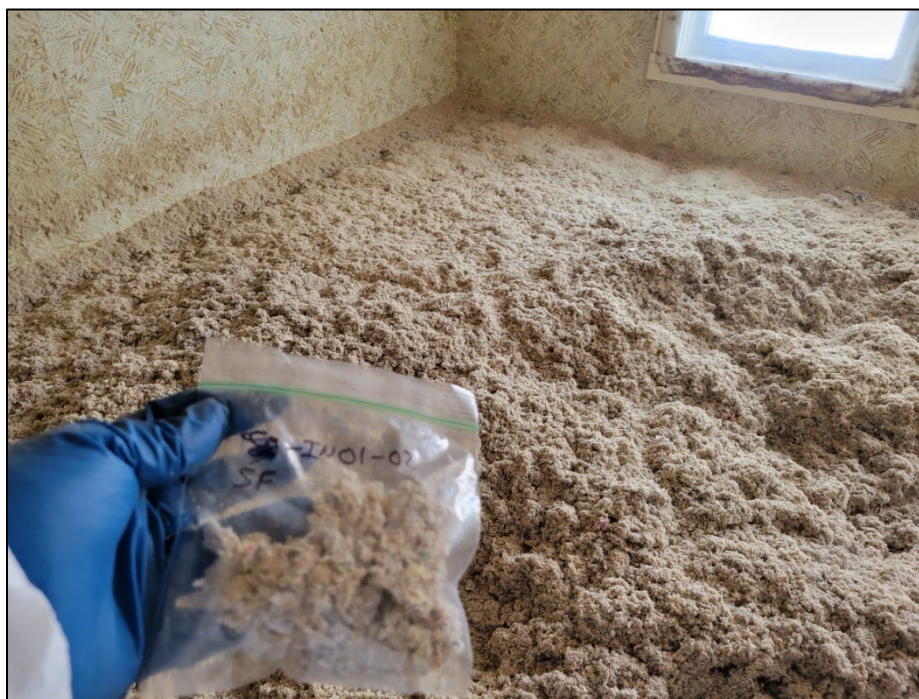
Photo 30. IN01: Loose insulation above Montana room and first floor

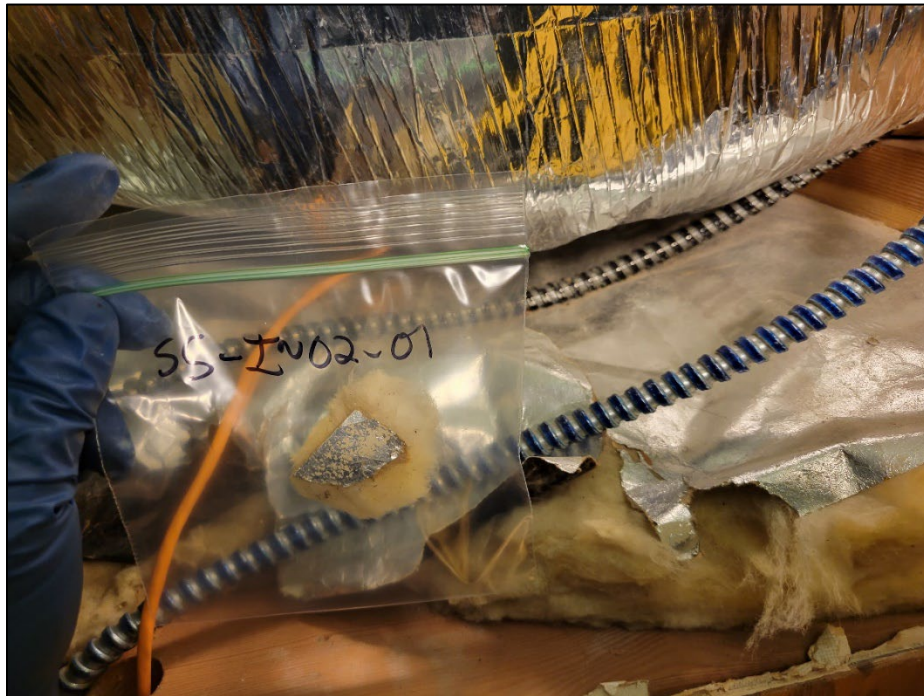
**Photo 31. IN02:** Batting insulation above IT room / office

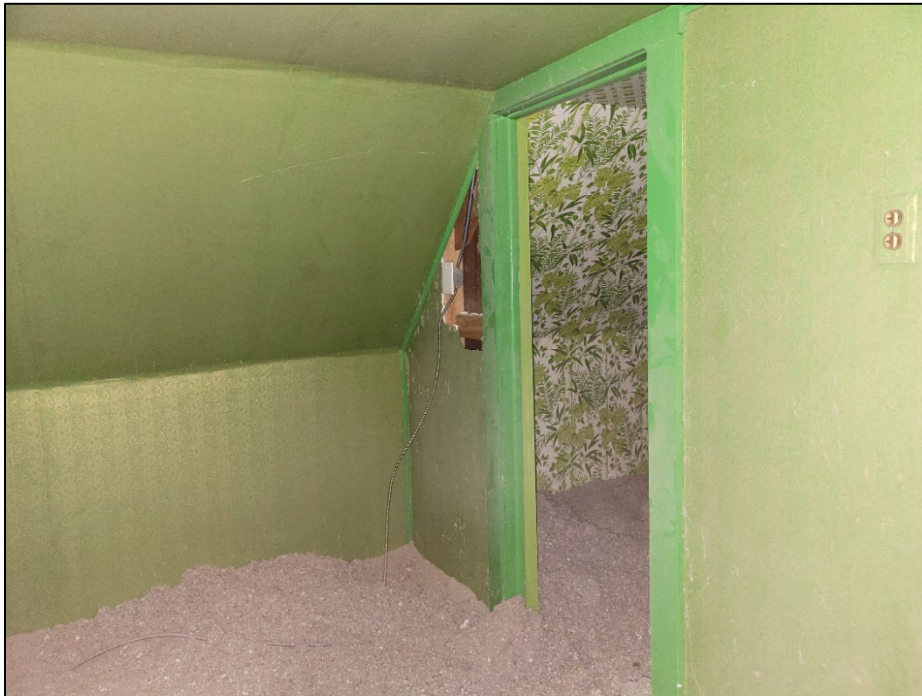
**Photo 15.** First floor drywall ceiling and walls containing ACM drywall beneath wallpaper. The loose insulation on the first-floor floor is non-detect.

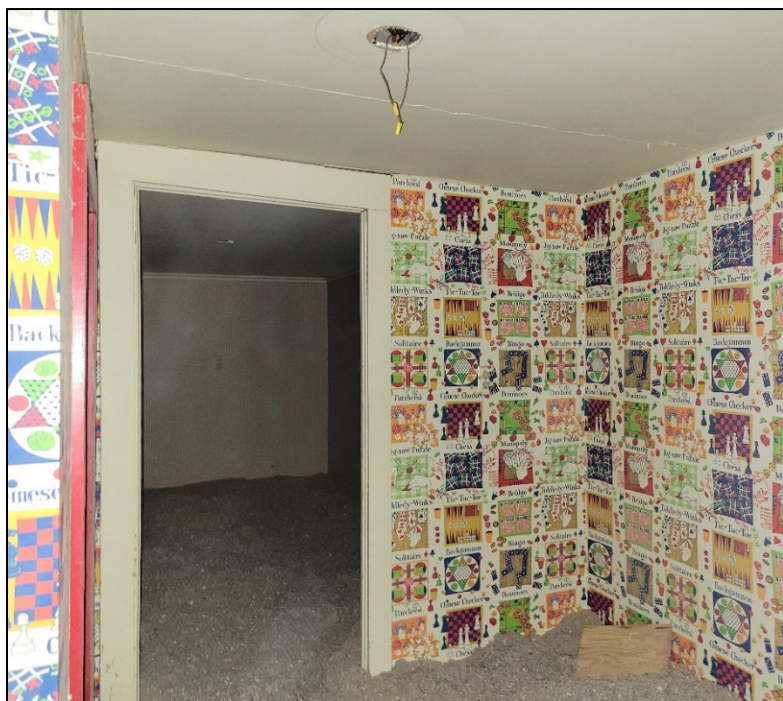
**Photo 16.** First floor drywall ceiling and walls containing ACM drywall beneath wallpaper. The loose insulation on the first-floor floor is non-detect.

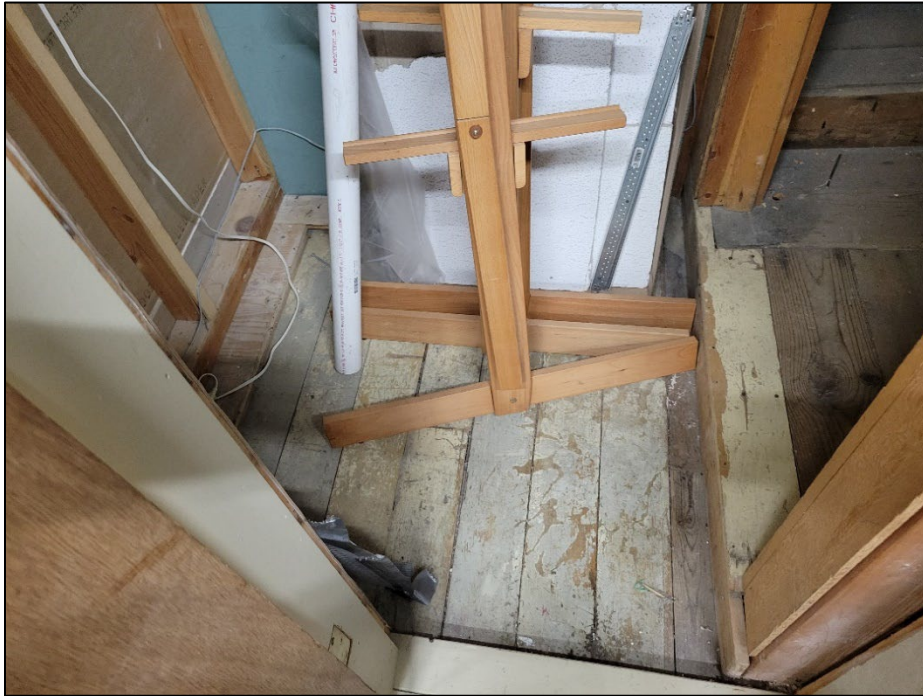
**Photo 1. LBP Sample ID #38:** White paint (3.2 mg/cm<sup>2</sup>) on storage room floor. Paint in poor condition and approximately 5 square feet.

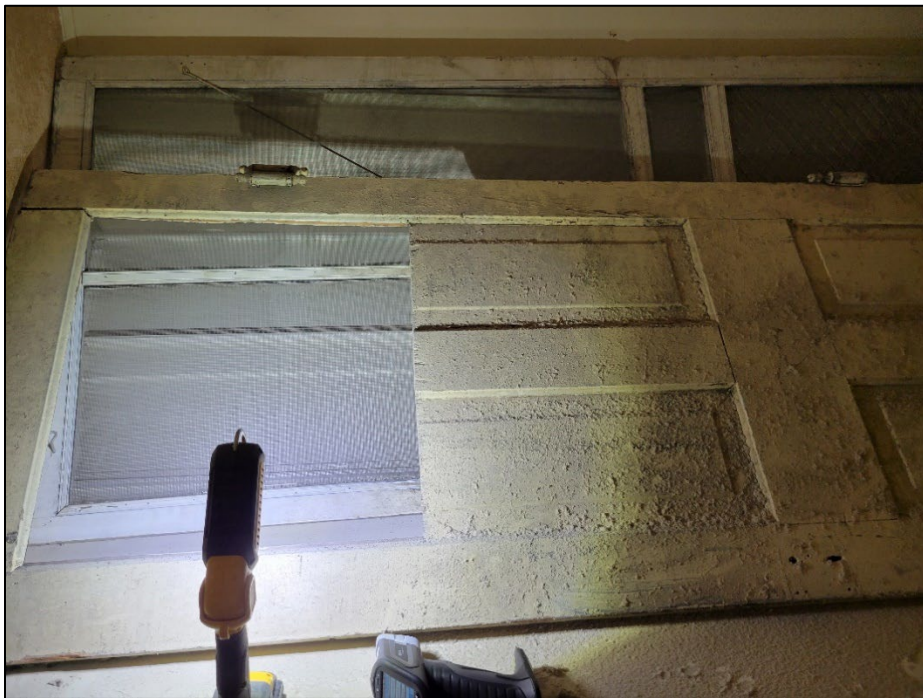
**Photo 2. LBP Sample ID #97:** Yellow paint (6.0 mg/cm<sup>2</sup>) stored door and door screen on first floor room next to bathroom. Paint in fair condition and approximately 10 square feet.
