North Valley Public Library  
Substructure  
11-14-2006

Substructure accesses are through hatches in the Montana room for the southern unit, and behind the front desk for the middle unit. The north unit has a slab floor, as far as I know.

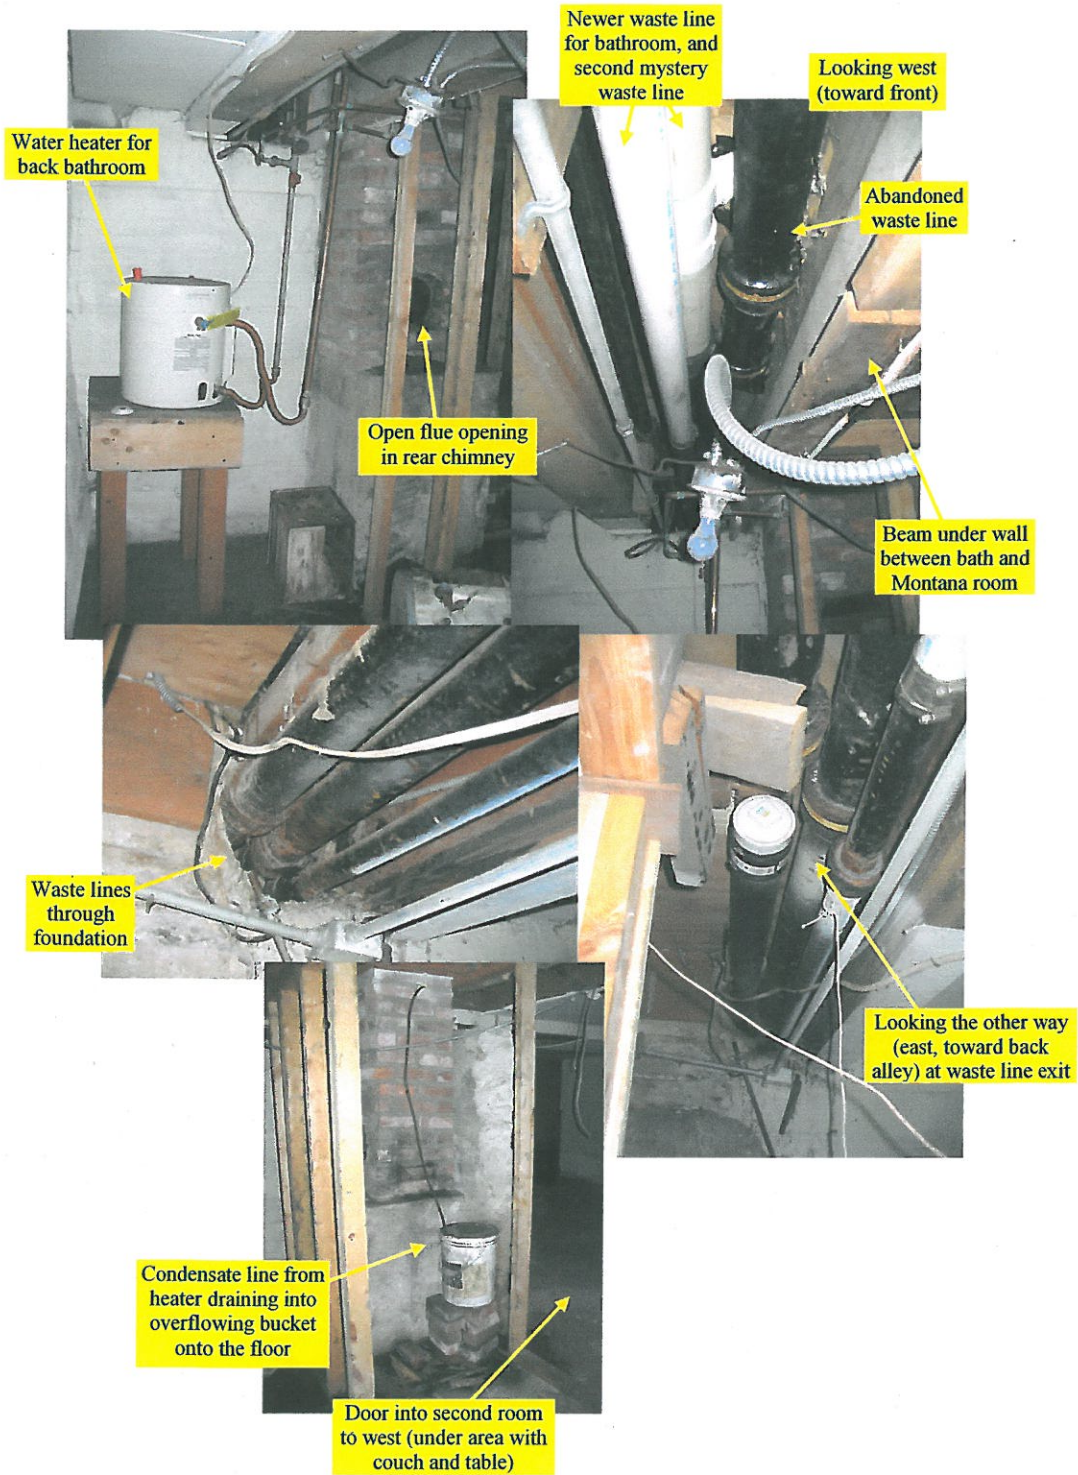
Significant water and moisture damage is occurring in the northeast corner of the structure. Water is soaking in from ground-level outside. Some of the structural components are molding, rotting, and structurally compromised. I don't think there is danger of imminent failure, but this must be addressed sooner rather than later.
