Re: Site Observation (2nd)
North Valley Public Library
208 Main St.
Stevensville, Montana 59870

On Wednesday, January 4, 2017, a representative from Eclipse Engineering made a site visit to the above stated address. The purpose of the visit was to investigate the condition of the roof framing after an issue with a roof beam (excessive deflection) was found during renovation.

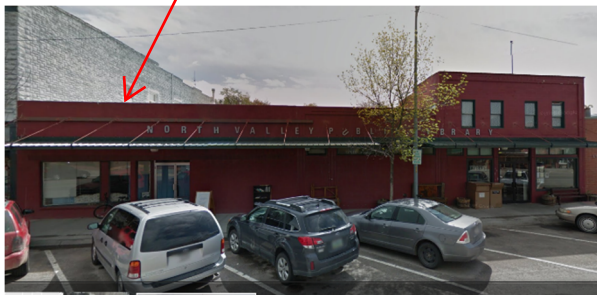
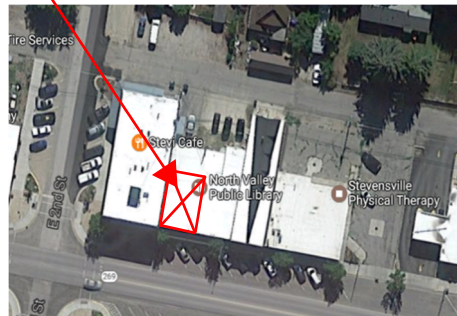
PUBLIC AREA WHERE BEAM IS LOCATED

Although the beam in question, (3) 2x10's, has not failed, the large deflection is a definite concern and it is recommended that it be replaced with a new (3) 1 ¾" x 11 7/8" LVL beam.

Attach all new and existing rafters to this beam with Simpson hangers. If required, the beam may be notched to match the bearing conditions of the existing (3) 2x10 beam, do not notch with a square cut, ref. detail A.
